# Navajo Abandoned Uranium Mine

# Site Screen Report

Mine Name: Charles Huskon No. 12
Mine ID: 119

August 2011

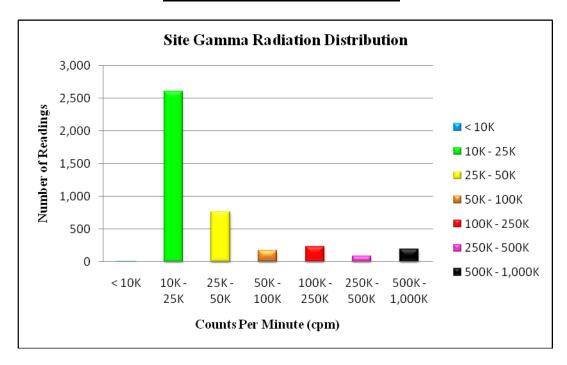
**Highest gamma radiation measurement:** 999,960 counts per minute (cpm)

**Background Average:** 11,493 cpm **Two Times Background:** 22,986 cpm

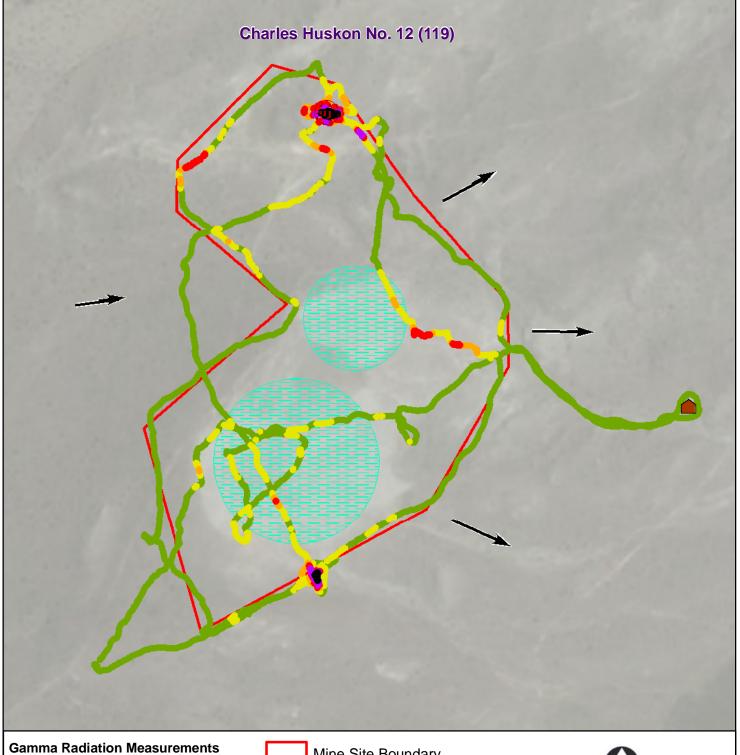
Figure 1 - Gamma Radiation Measurements, Above Two Times Background
Charles Huskon No. 12 (119)
Coalmine Mesa Chapter, Navajo Nation

A total of 4,045 gamma radiation measurements were collected from the mine site, ranging from 8,927 cpm to 999,960 cpm. Measurements collected in the vicinity of the waste rock were found at a maximum level of approximately 1,000,000 cpm, and the reclamation area of approximately 200,000 cpm. The measurements are represented in Figures 1 and 2.
